APACHE TRIBE OF OKLAHOMA HOUSING AUTHORITY TRIP REPORT

Assessment of Mold and Moisture Conditions

Final Report

Prepared for:
U.S. Department of Housing & Urban Development
Office of Native American Programs

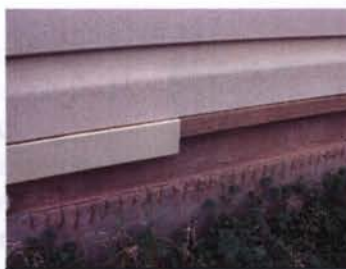
Figure 1: Missing siding

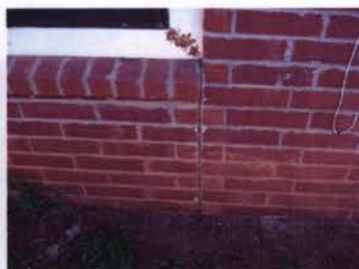
Figure 2: Incompletely sealed expansion joint

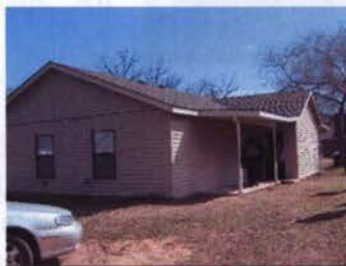
Figure 3: No gutters; porch added to protect from rain

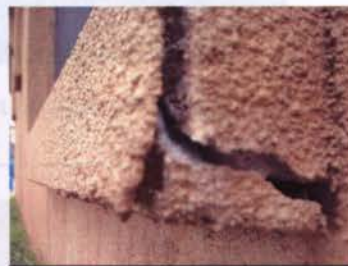
Figure 4: Cracks in stucco windowsill

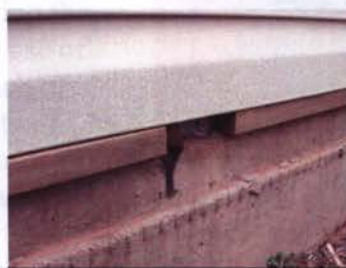
Figure 6: Potential water entrance

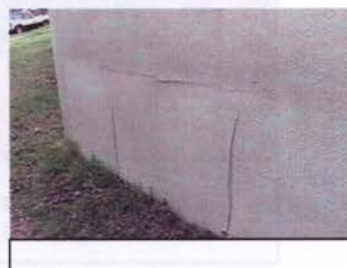
Figure 5: Cracks in stucco

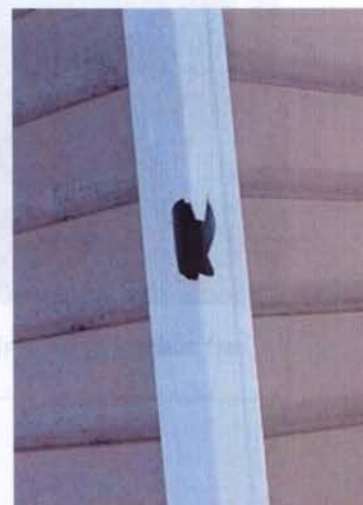
Figure 8: Hole in vinyl siding

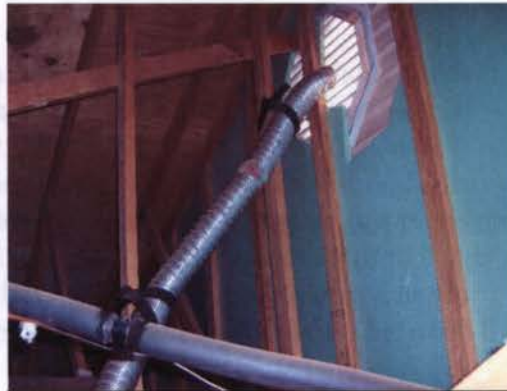
the gable (Figure 9) but we also found fans without any ductwork (Figure 10), such that the exhaust was blown into the attic insulation and then into the attic. In some cases, fans without ducting had blown a cavity around them in the insulation, whereas others remained completely covered. The home with Styrofoam and stucco did not have any exhaust fans. Typically an "on/off" switch controlled bathroom exhaust fans. All the bathroom fans were quite noisy. Occupants tend not to use noisy fans.

Figure 9: Exhaust fan ducted to gable vent

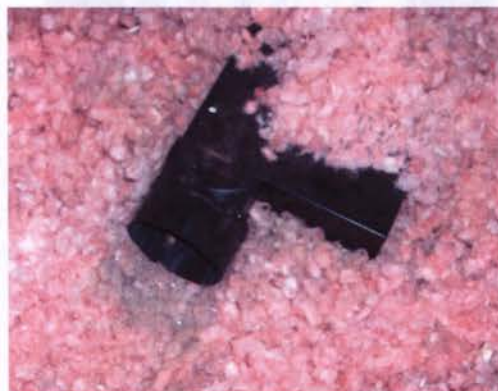
Figure 10: Unducted exhaust fan venting into attic insulation

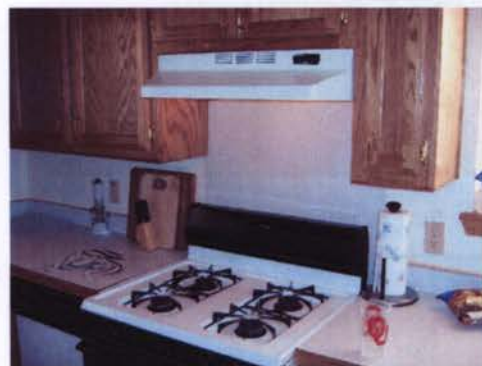
One home had a kitchen fan that exhausted to the outside. Three homes had recirculating kitchen fans (Figure 11), and the remaining two homes did not have kitchen fans. Recirculating fans can remove some grease and solid cooking residue, but have no effect on moisture. Venting kitchen exhaust fans to the outside is imperative to controlling moisture levels while cooking, especially in a home that has been weatherized.

Figure 11: Recirculating kitchen fan

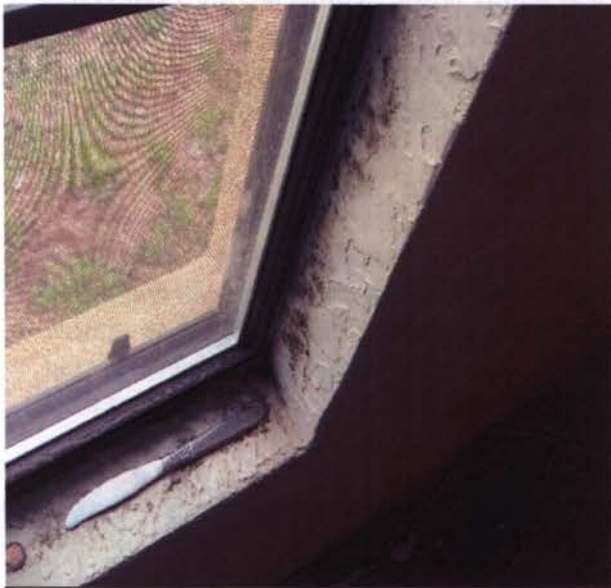
Condensation often provides enough moisture to allow mold growth. Although moisture removal with proper ventilation will eliminate most condensation, the use of metal windows can leave a cold surface in the interior. This cold surface will condense moisture if the ventilation is weak and the humidity is high enough (Figure 12). Heavy draperies can also lead to condensation on windows (Figure 13). Most homes place the supply air vents near the perimeter walls so that the hot air will wash moisture off the window surfaces. If heavy draperies are used, they will trap the moist air in a dead pocket and promote condensation. Furthermore, they may act as insulation between the window and the warmer house air.

Figure 12: Condensation on metal window frame

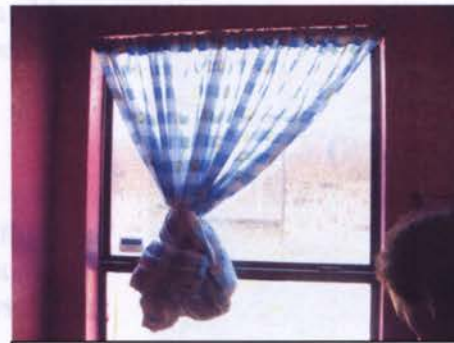
Figure 13: Heavy draperies can lead to condensation on windows

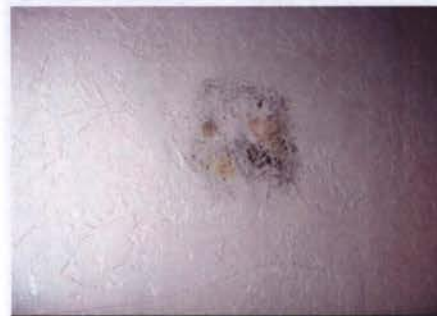
The home with Styrofoam and stucco had significant mold at the base of the walls and in a location in the center of one wall (Figures 14 and 15). This was almost certainly due to water penetrating the wall from outside. If the foam contacted the ground, this could lead to soil moisture being brought up and into the wall.

Figure 14: Mold in center of wall

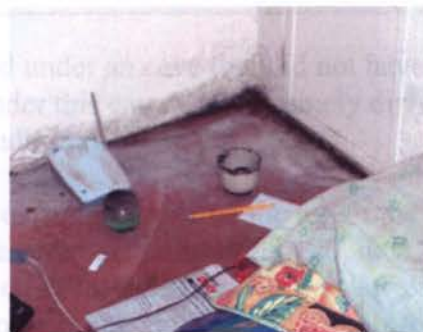
Figure 15: Mold at base of wall

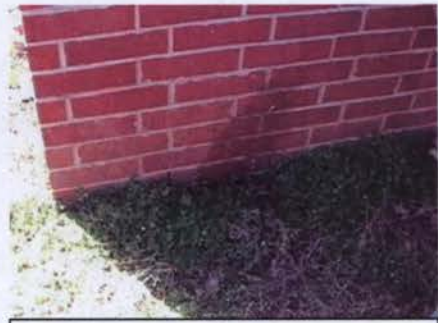
Figure 16: Wet area at perimeter of home

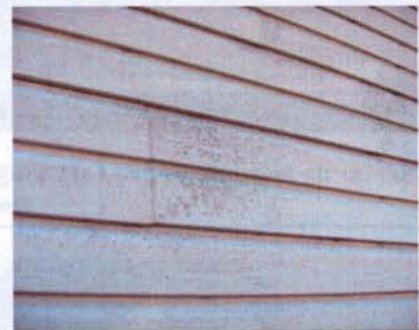
Figure 17: Mold on vinyl siding

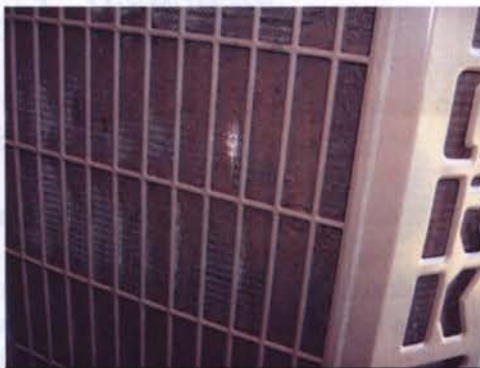
Figure 18: Dirty air conditioner outdoor coil

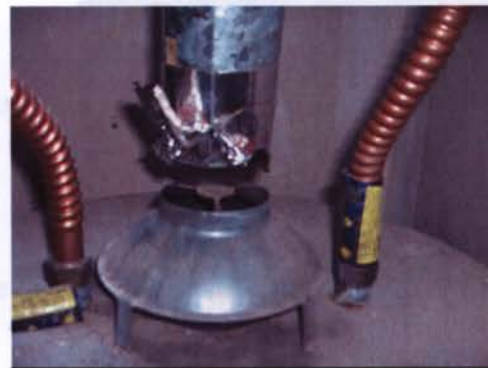
Figure 19: Disconnected flue pipe

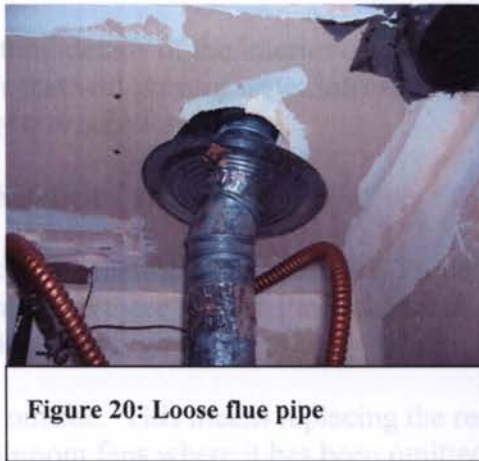
Figure 20: Loose flue pipe

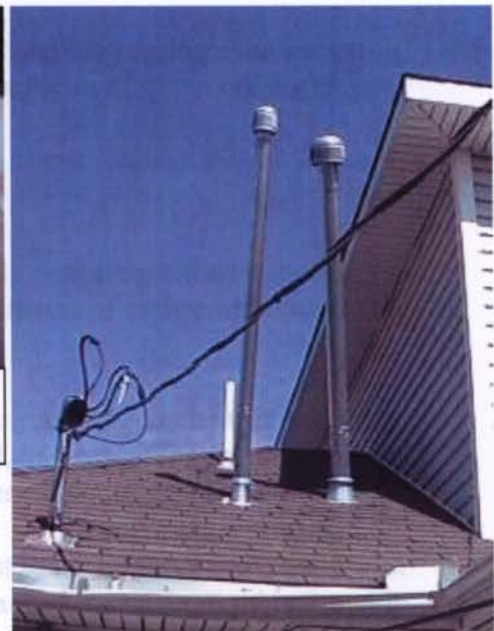
allow for combustion air were exceptionally long, extending several feet above the roof (Figure 21). This length is unnecessary for this type of vent.

Figure 21: Long combustion air intake vents

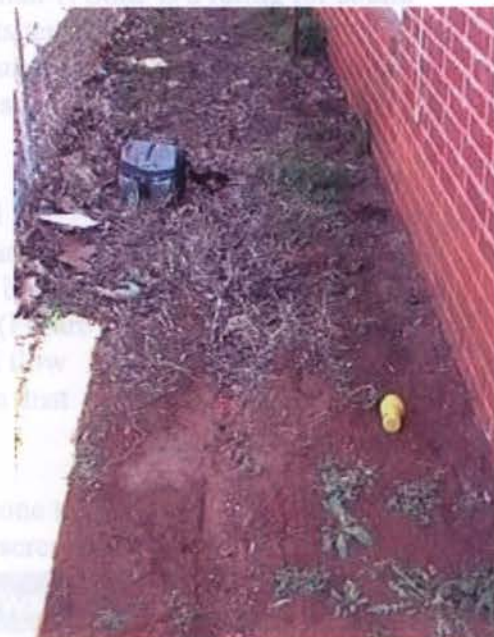
Figure 22: Drip line between homes

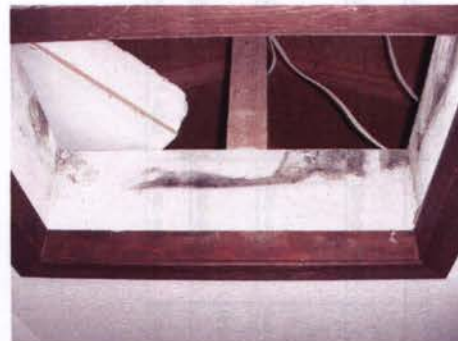
Figure 29 – Mold growth on a non-air sealed attic access opening

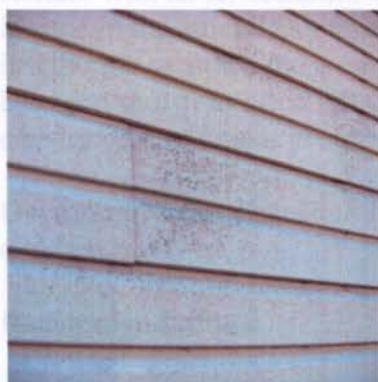
Figure 2: Mold on vinyl siding

Conditions: No mold was within the unit, but was on the exterior of the vinyl siding on the northern exposure (Figure 2), probably caused by dirt on the siding.

1. Install leaders and splash blocks where needed on downspouts.
2. Carefully wash north siding to remove soil and dirt along with mold and mildew. A high-pressure wash will be faster and easier, but may get water under the siding and wet the sheathing. A low-pressure wash (e.g. with a garden hose) will take longer but poses less risk of wetting materials under the siding.
3. Push insulation into cavities where building materials blocked the blown-in insulation from filling.
4. Air seal hatches to attic using weatherstripping.
5. Vent bathroom fans all the way to the outside, not just to the gable vents.
6. Install mechanical or fan-delay timers as bathroom exhaust fan controls.
7. Install a kitchen range hood that exhausts to outside.

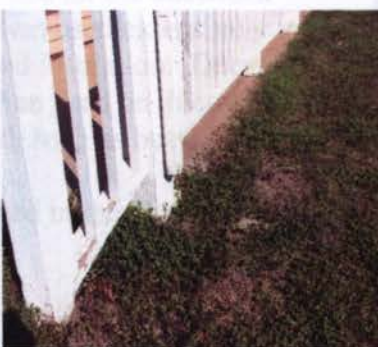
Figure 3: Missing leader and splash block

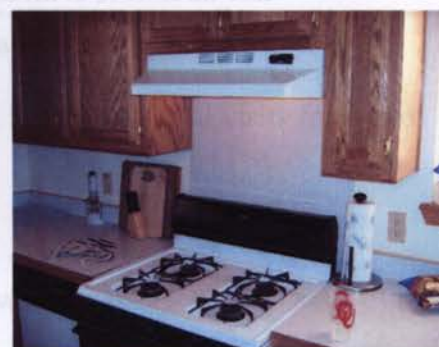
Figure 4: Recirculating range hood

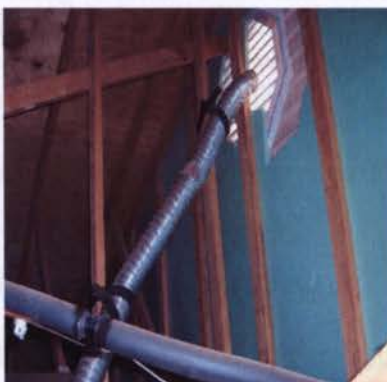
Figure 5: Bathroom fan vented to gable vent

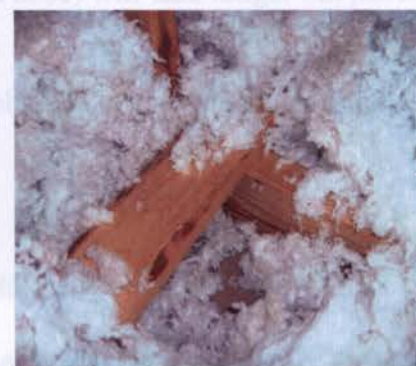
Figure 6: Insulation void under stiffener board

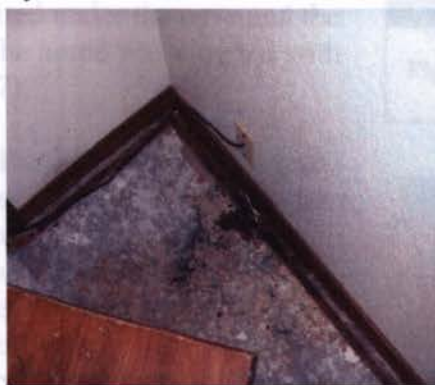
Mold had been reported for some time under the living room and rear bedroom carpets (Figure 2), on the bathroom walls, and around windows (Figure 3). Mold was also observed on the wall behind the toilet. The mouldings at the base of the rear bedroom walls showed signs of extended wetting.

Figure 2: Mold on bedroom floor (carpet had been removed)

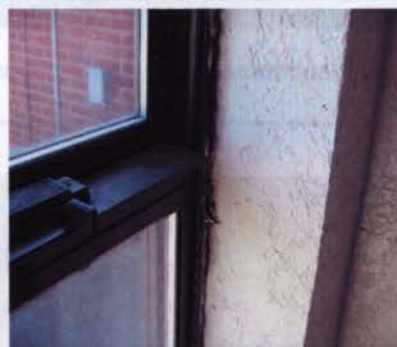
Figure 3: Mold around bedroom window

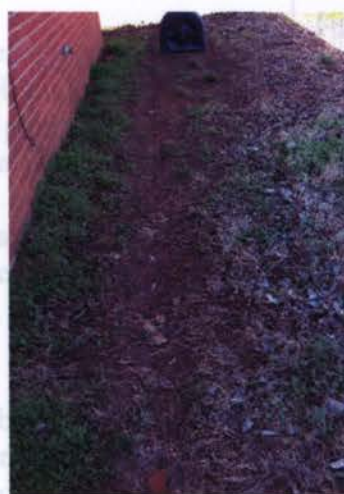
The site was flat and the home had a very limited gutter system. A drip line was beneath the eaves of the home (Figure 4). Both ATOHA and the occupant reported water standing alongside the home after a rainfall event. It is likely that the water in the living room had entered through an unsealed expansion joint in the brick façade at grade from ponding after rainfall events (Figure 5).

Figure 4: Drip line below eaves

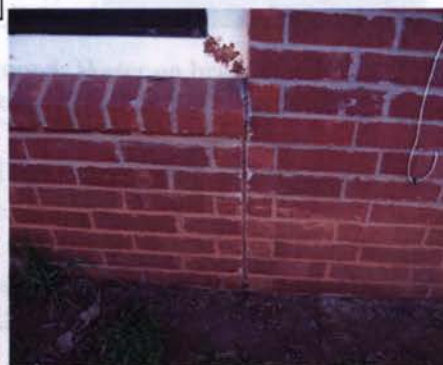
Figure 5: Expansion joint incompletely sealed at bottom

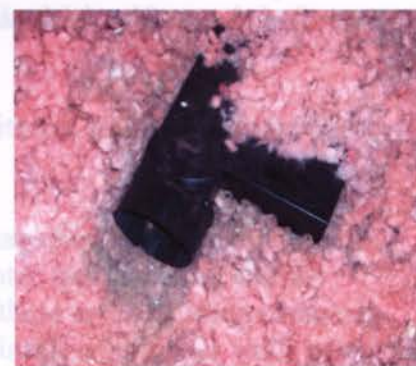
Figure 6: Bath fan exhausting to attic and no ductwork present

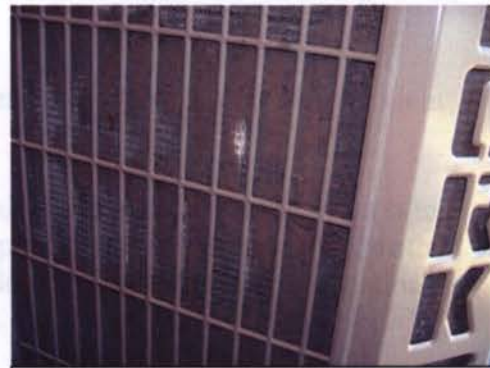
Heating System: The home had a natural gas forced-air furnace with an air conditioner, with all the ductwork located in the attic. The exterior condenser coil was located under the eave and the coil on the side facing the home was clogged with dirt and debris (Figure 7).

Figure 7: Clogged air conditioner coil

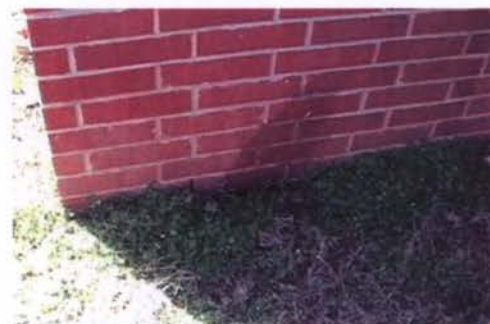
Water Penetration at Rear of Home: The rear bedroom showed evidence of significant long-term wetting. This was almost certainly caused by a plumbing leak at the back of the home. A wet spot was evident along the rear perimeter wall about four feet from the corner of the home (Figure 8). The ground immediately below this wet spot was saturated, while the ground on either side was dry. The occupant reported that this spot has been wet for eight years.

Figure 8: Water on brick at rear of house

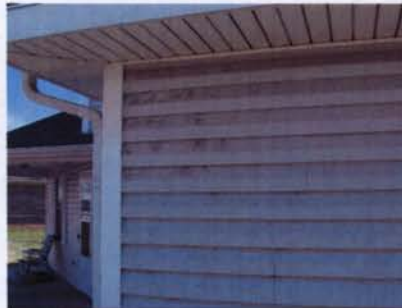
Conditions: No mold was found inside. However, significant mold was found on the dirty exterior vinyl siding (Figure 2).

Figure 2: Mold on vinyl siding

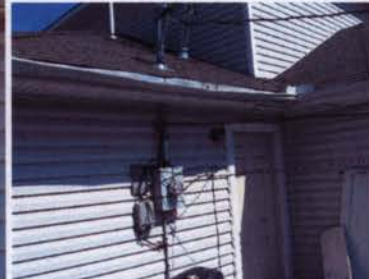
Figure 3: Damaged gutter

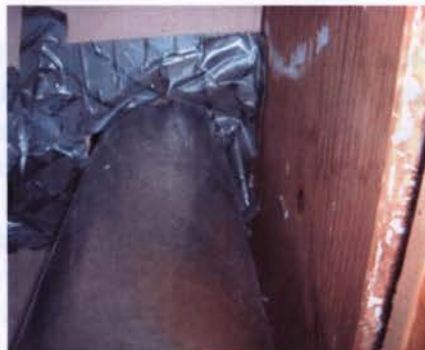
Figure 4: Failing duct tape around combustion air intake

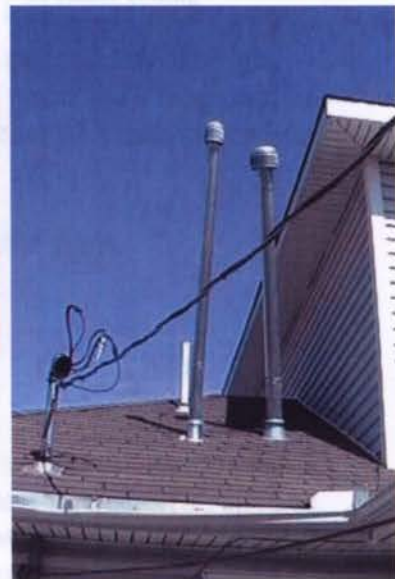
Figure 5: Excessively long intake ducts

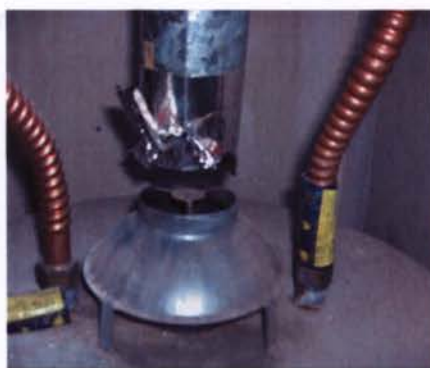
Figure 6: Disconnected water heater flue

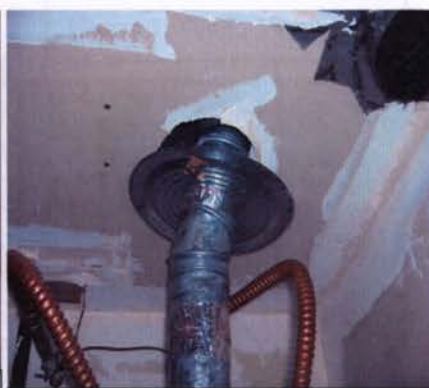
Figure 7: Loose water heater flue at closet ceiling

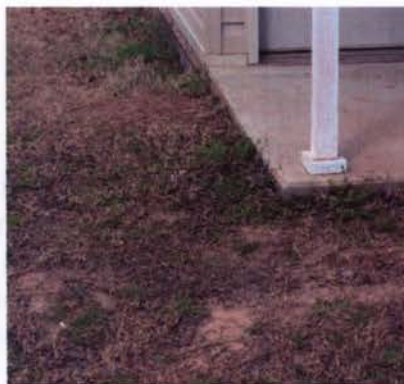
Figure 2: Depression in soil adjacent to home

The site was flat with no gutters. Depressions were found near the foundation (Figure 2) and where the earth near the foundation was close to the bottom plate above the slab (Figure 3). ATOHA recently constructed porches, front and rear, to keep the surface stormwater away from the entrances and prevent a recurrence of the 2004 problems. However, the potential for groundwater entry remains. The slab was poured several years prior to the home being built on it and any small cracks in the slab could promote groundwater intrusion. ATOHA should monitor this.

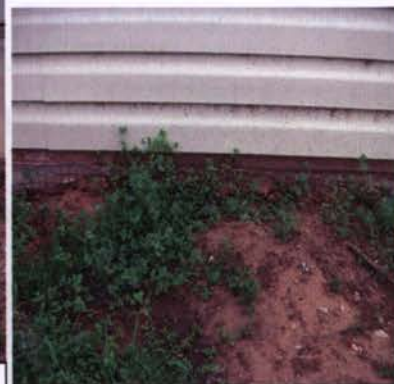
Figure 3: Soil rising to bottom plate

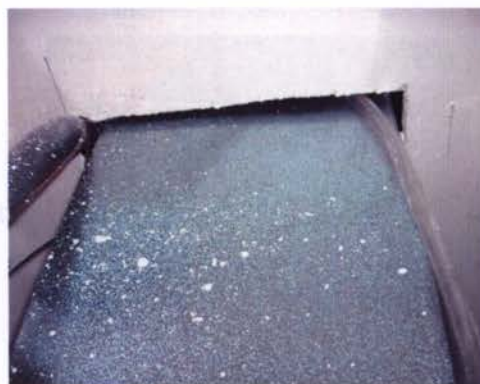
Figure 4: Unsealed penetration for ducts through ceiling

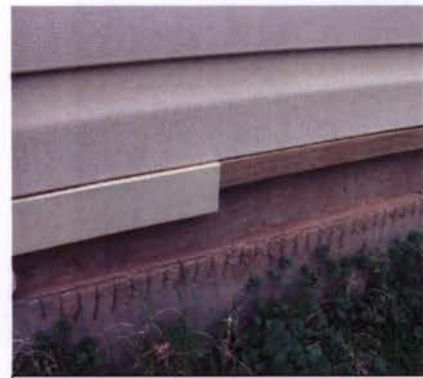
Figure 5: Incomplete siding over bottom plate

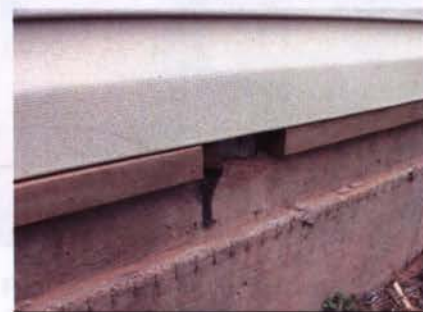
Figure 6: Gap in bottom plate

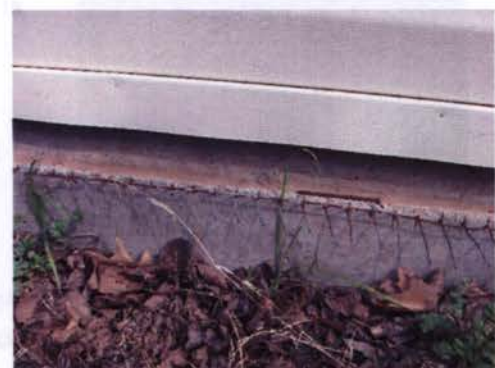
Figure 7: Untrimmed slab reinforcing mesh

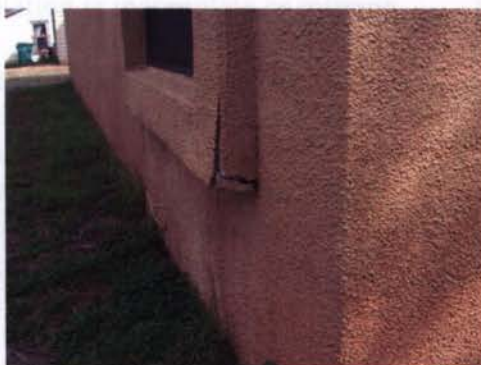
Figure 2: Stucco deterioration around window

In this home, the stucco was deteriorating (Figures 2-4). Possibilities for the cause of the cracking included; freeze/thaw of moisture, other expansion/contraction of the stucco, or an unidentified installation defect. This allowed both moisture and cold air to enter the walls. The cracking had not progressed further due to the stress relief caused by the initial cracks. Simply sealing the cracks would probably lead to additional cracking.

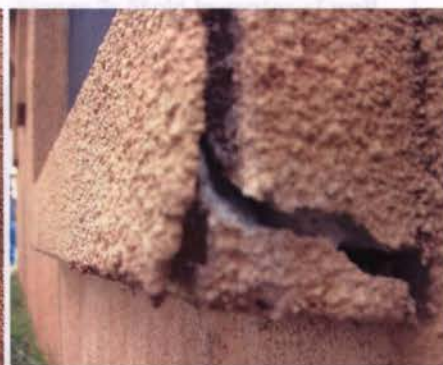
Figure 3: Close-up of stucco deterioration

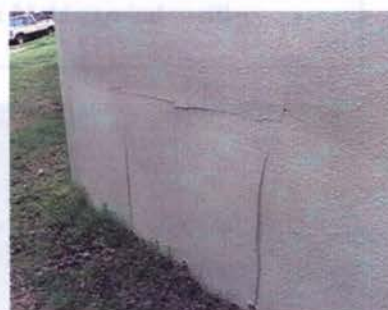
Figure 4: Cracks in stucco

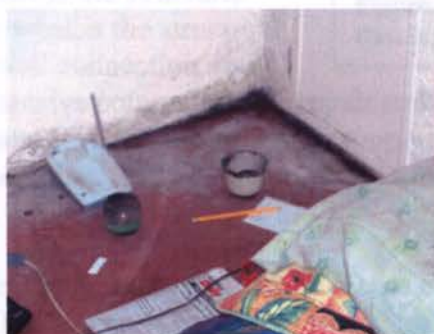
Mold was on the bottom of walls (Figure 5), at a wall and ceiling juncture (Figure 6),

Figure 5: Mold at bottom of walls

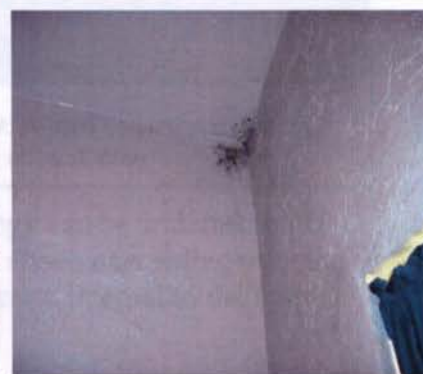
Figure 6: Mold at wall/ceiling juncture

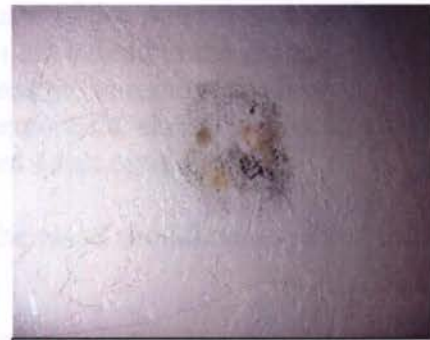
in the middle of one wall (Figure 7), and on windowsills (Figure 8). Some of this mold was clearly a result of water penetration through the building envelope, such as the mold at the base of the walls. Other mold was more likely a result of high humidity levels indoors combined with low ventilation rates, such as the mold at the wall/ceiling juncture and the mold around the windows. When a thermal bridge, allows interior surfaces to be cold, condensation can result in mold growth. This can happen at windows, or if the Styrofoam insulation is incomplete or missing.

Figure 7: Mold in center of wall

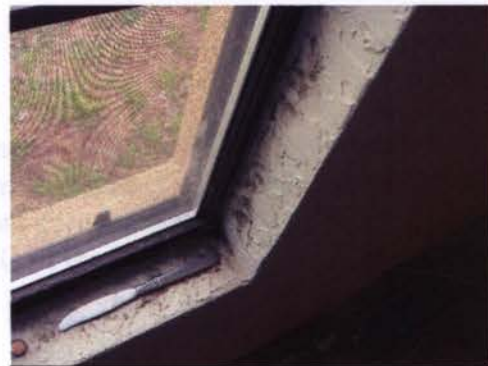
Figure 8: Mold at windowsill

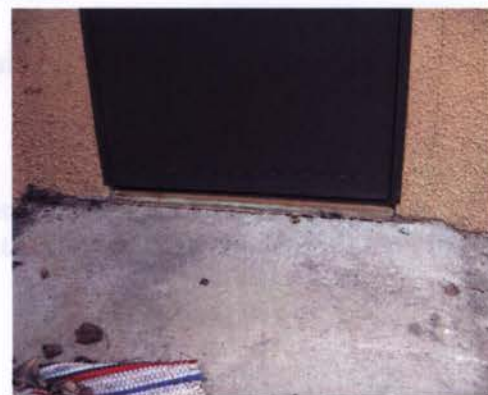
Rainwater Management: The site was flat and there were no gutters. Water often was standing alongside the home after a rainfall event. It appeared concrete had been added at the back door to improve the grading and prevent ponding, although the flashing at this door was inadequate (Figure 9).

Figure 9: Added concrete, deficient flashing at back door
